Seawalls, Groynes and Breakwaters: Their impacts on the Kerala's beaches and small-scale fisheries

D. Nandakumar and A.J.Vijayan

INTERNATIONAL COLLECTIVE IN SUPPORT OF FISHWORKERS (ICSF)
2015-16, DRAFT REPORT FOR COMMENTS
INDIA STUDY: CONTEXTUALIZATION OF SSF Guidelines

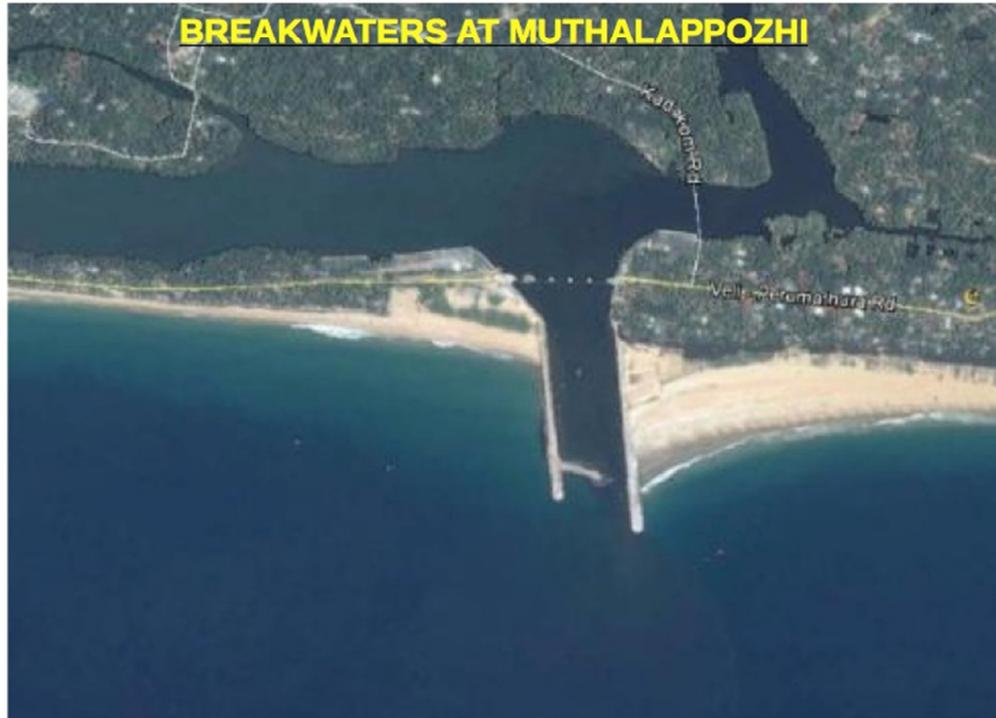
Source: Google Earth Pro, August 2015.

Thazhampally present the opposite scenario. It is one of the badly hit fishing villages in terms of coastal erosion. Many households were relocated and people resettled across the Chirayinkeezhu backwaters. This village is in the northern side of the Muthalappozhi.

In Adimalathura (South of Vizhinjam breakwaters) and Perumathura (South of Muthalappozhi breakwaters) higher accretion is observed in the southern side adjacent to the breakwaters, much more than any other study locations even in the northern districts of Kerala.

In Adimalathura, accretion extended to form a wide beach of more than 350 meters from the existing road. People's strategy was to claim the land by planting coconuts and fencing it off as individual property. Currently, that entire accreted land is occupied. The community institution (church) made a rule that people should not put up houses or privatize on the western side of the new road on the beach, while public utilities are promoted. The youth are happy that they have football and cricket grounds in these newly formed beaches. People take out sand also from the newly formed beaches to 'create' land and to construct houses elsewhere.

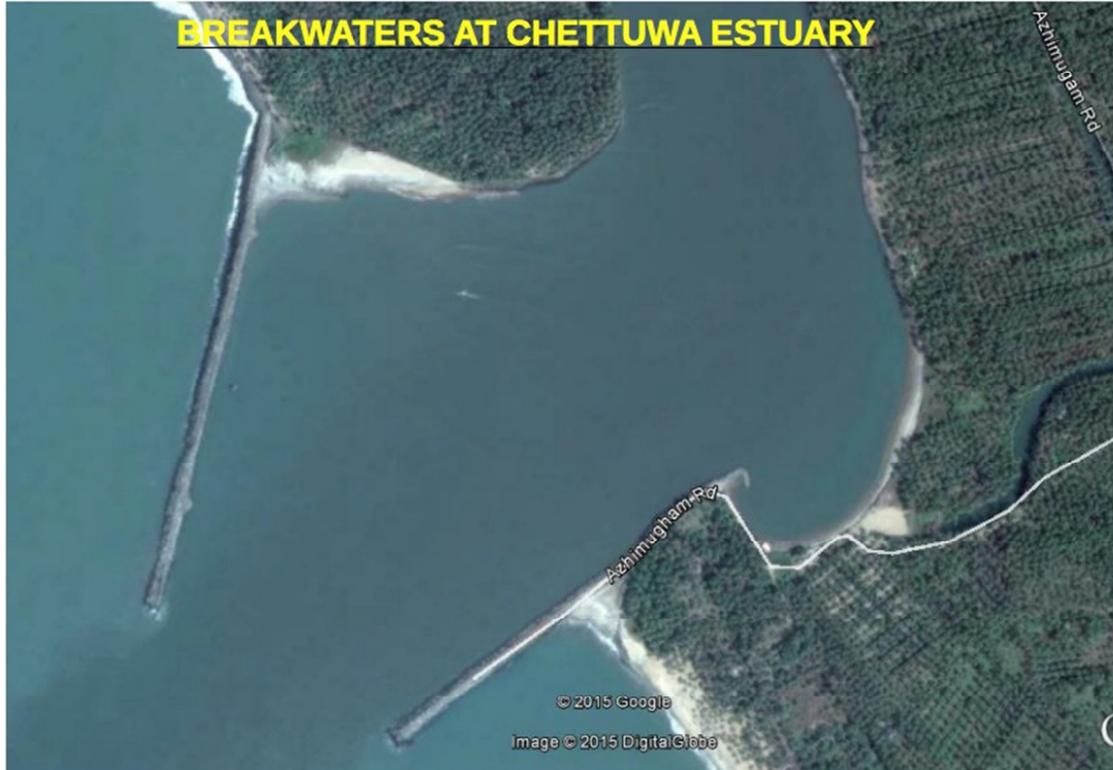
Source: Google Earth Pro, August 2015.

Seawalls are constructed all along Chavakkad to Nattika but in many locations they are dilapidated or submerged in sea. Blangad beach in Chavakkad Municipality area, is a stable beach. Thalikkulam (Snehatheeram) has a stretch of evenly eroded sandy beaches. North of Nattika, after a small stretch of stable beach, many sea walls were observed. Interviews with the local folk revealed that erosion occurs all through the year.

In 2011, the Chettuva fisheries harbour (locally called Banglayan harbour) was built on the Engandiyur side, south of Chettuva lake. On both sides of the bar mouth, two breakwaters were built in 2010-12 period. This construction could be part of the new fishery harbour on the Engandiyur side. There is heavy erosion on both sides of the breakwaters. Local people complained that the design/construction of breakwaters is not proper. According to them this construction has led to more problems. They pointed out that water channels inland are clogged with sand while river banks are eroding. Severe erosion is observed on the southern side after the breakwaters were built. Electric posts right on the beach stand testimony to the intensity of erosion. Interviews at the location revealed that a house with 65 cents of land was engulfed by the sea.

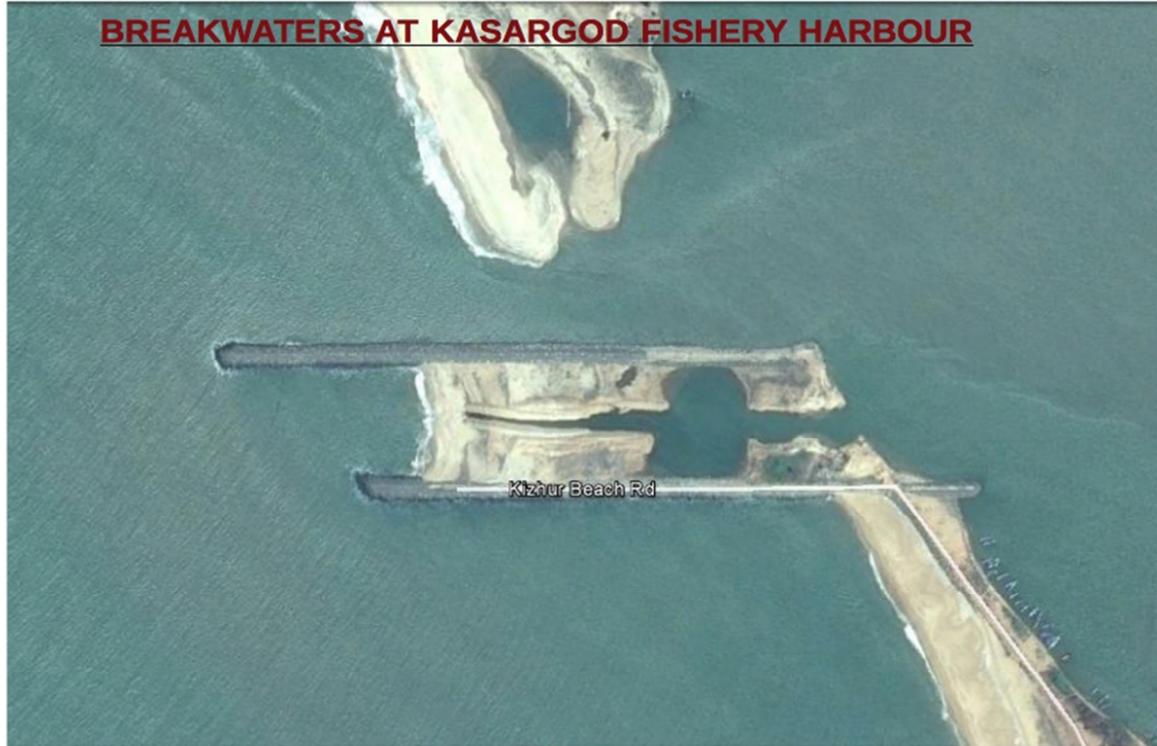
Source: Google Earth Pro, August 2015.

Though silting up of the river/estuary mouths is common to all three locations, its intensity is very high at Keezhur in Kasargod district. Chandragiri river discharges its waters and sediment here at Keezhur as it is unhindered by any dams or reservoirs. Field visits and local interviews revealed that this estuary is highly dynamic and the sedimentation within breakwaters constructed clogged the entire boat channel.
